Production and Assessment of Fatigue Damage in 2024-T3 Aluminum Samples

- Supervisor and Professor: Dr. Conley
- Undergraduate research assistant: Jared Goldsmith
- Organization: NDI Validation Center (Sandia National Labs)

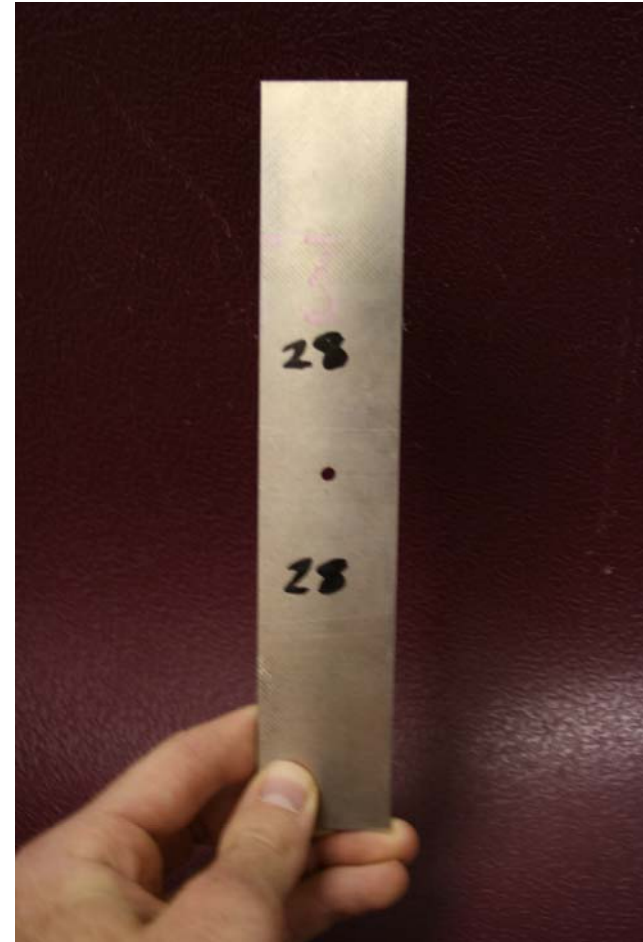
- Sandia has supplied us with 8x1.5x.04 inch 2024-T3 aluminum specimens with a 5/8 inch hole drilled in the middle. Each specimen represents a section of airplane skin with a rivet hole drilled in it.
- The purpose of our research is to produce fatigue in our specimens by subjecting them to a series of tension cycles imitating the pressurizing and depressurizing of an airplane hull.

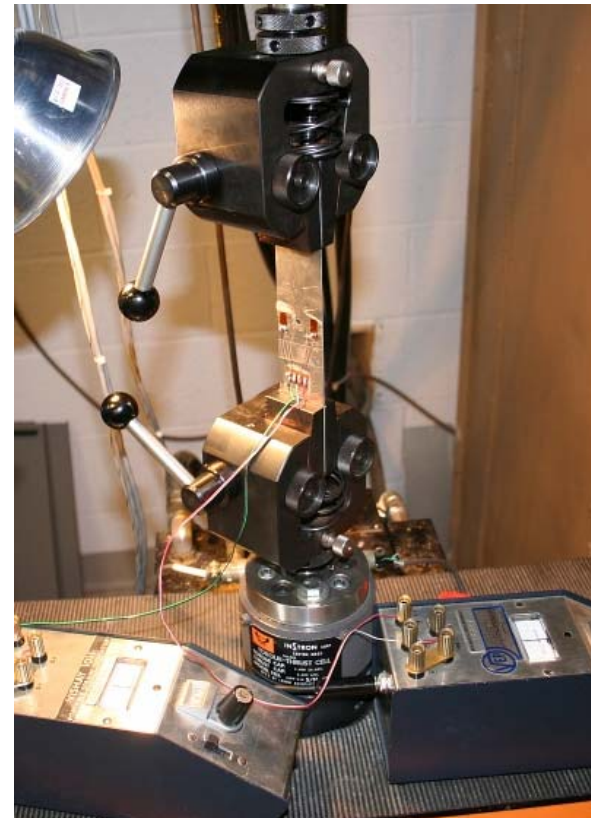
- The first task was to run our Instron tensile machine in a series of load block cycles in accordance with the $R=.1$ specifications.
- $R=.1$ requires the cycle tension in the specimen to alternate between 20ksi and .2ksi.
- A Lab View VI was created to produce a DC voltage from the DAQ card to the Instron machine to control tension cycling of the machine.

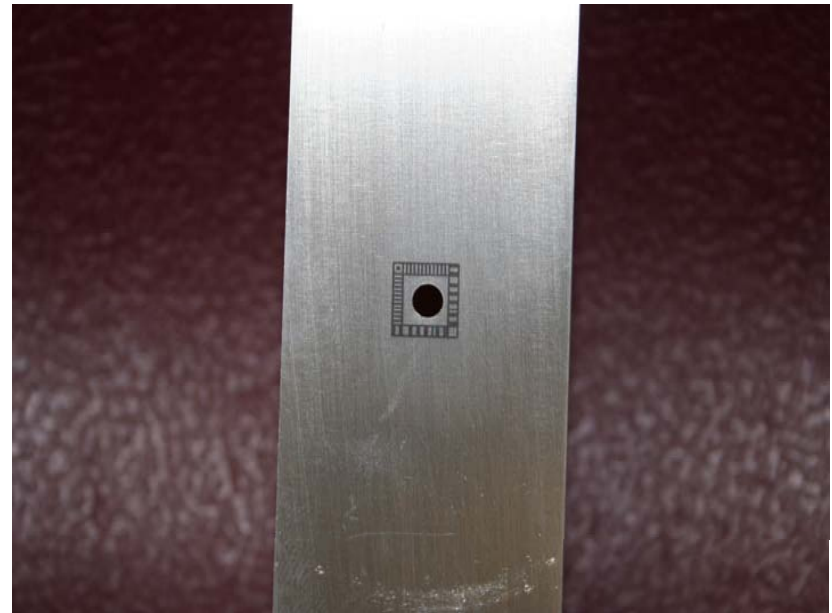
- 15 specimens with bar codes were sent to us from Direct Measurement Inc.
- Each specimen was put through 10 cycles and then sent back to DMI.

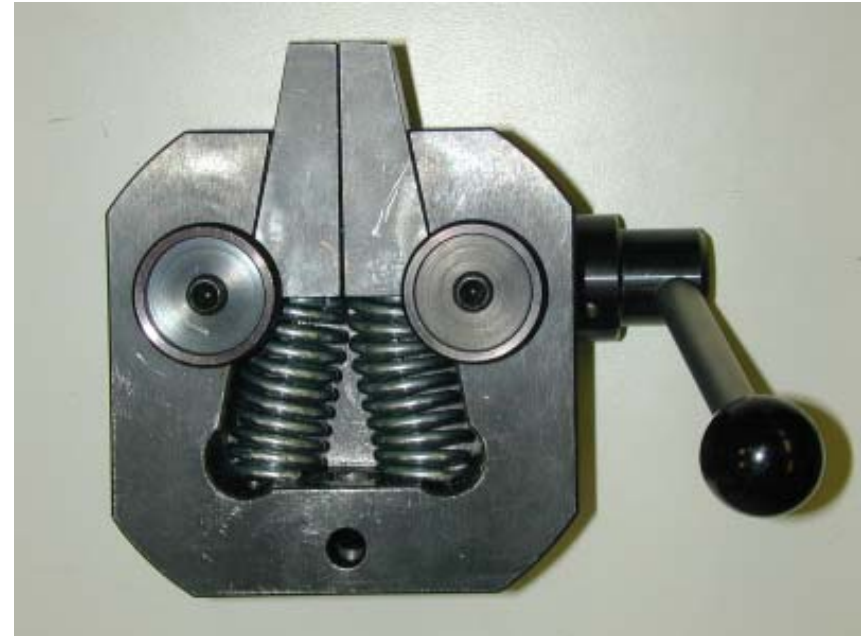
- Results came back from DMI saying the every specimen had undergone some compression.
- Found that while inserting the specimen into the clamps, it was undergoing slight compression.
- Solution: turn the load command on first and then clamp the specimen.
